LABORATORY TESTING OF ROCK BOLT STRESS CORROSION CRACKING

Erwin Gamboa¹ and Andrej Atrens¹

ABSTRACT: The incidence of Stress Corrosion Cracking (SCC) in rock bolts has not been quantified and its magnitude has not been addressed. A laboratory test has been achieved that causes a tensile sample to fail in a manner similar to the failure mode observed from service failures, namely slow SCC followed by fast brittle fracture. The laboratory tests involve subjecting a tensile sam²ple to a linearly increasing stress at a slowly applied stress rate whilst the specimen is exposed to a dilute sulphate solution of pH 2.1. Detailed fractography of SCC fracture features from the LT has shown that these fracture surfaces have the same features as fracture surfaces of service failures. An SCC velocity can be calculated from these tests. This SCC velocity can be used to evaluate the benefit provided by a material with a higher fracture toughness. The SCC velocity measured from the laboratory tests indicates that the SCC lifetime is increased only marginally by the use of a rock bolt materials with a higher fracture toughness

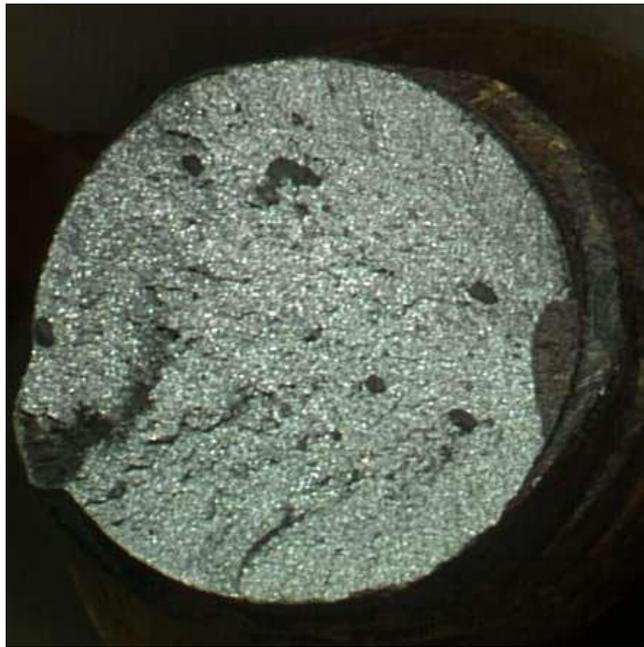
FIG. 2(a) - Overview Of Service Fracture

A detailed comparison was carried out between LIST tests of Steel *A* exposed to the Sulphate pH 2.1 solution and Steel *A* rock bolts failed in service. There were the same fracture modes in both the service and laboratory samples. The fractures involved a small SCC region followed by a large fast fracture (FF) region. Figure 2 provides a typical overview for a service fracture. The images of Figure 2 represent optical images. The SCC region is easily identified by its darker colour due to the presence of corrosion products on the metal surface in the SCC region. This is due to the fact that the stress corrosion cracks grew slowly, allowing a period of time for corrosion to occur. In contrast, the overload region occurred essentially instantaneously, so that the surface was bright and shiny as an un-oxidized steel surface. The tear lines radiated away from the fracture origin. These tear lines facilitated the identification of the SCC feature that initiated the final fast fracture event. It was particularly noteworthy that the service stress corrosion cracks often initiated in association with the ribs on the surface of the rock bolt as illustrated in Fig. 2(b).

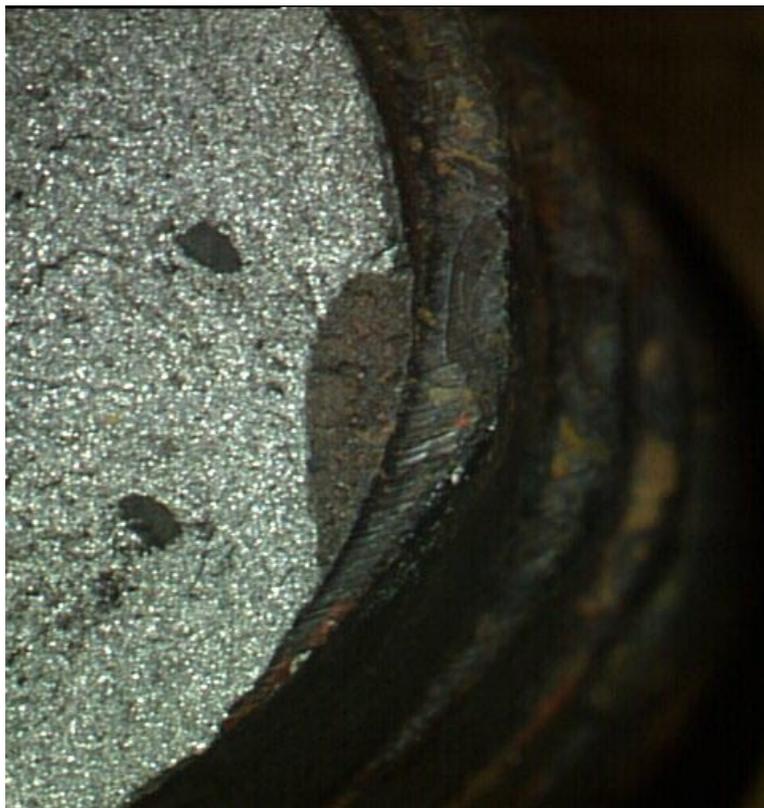
FIG. 2(b) - Service Fracture – Relation Of SCC To Rib
